## USAAMRDL TECHNICAL REPORT 73-20

# MANUFACTURING METHODS TECHNOLOGY (MM&T) FOR BALLISTIC-TOLERANT FLIGHT CONTROL COMPONENTS

May 1973

**CONTRACT DAAJ02-71-C-0062**  
**WHITTAKER CORPORATION**  
**RESEARCH AND DEVELOPMENT DIVISION**  
**SAN DIEGO, CALIFORNIA**

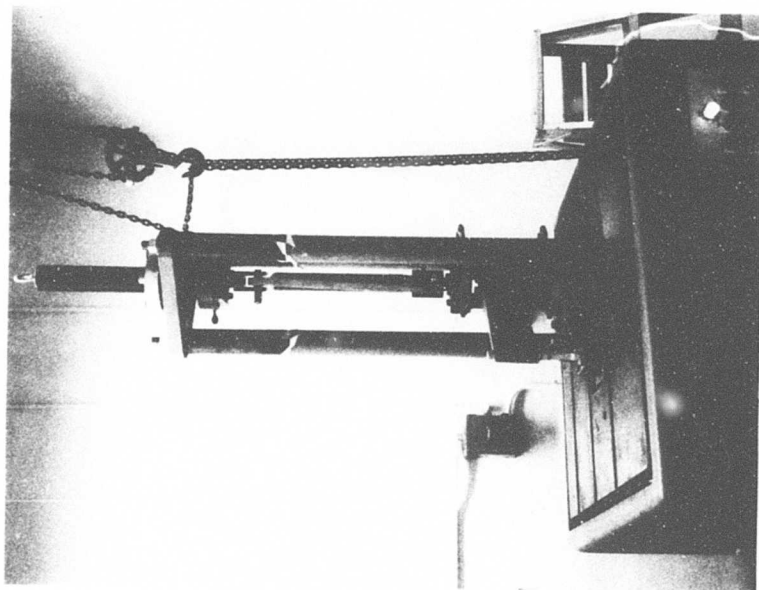
Figure 35. Cyclic Loading of Connecting Link.

The fatigue tests were conducted on set no. 6, as shown in Table VIII, column B. Component sets no. 2, 4, and 5 were cyclic loaded for a total of 5,000,000 cycles. The loads are listed in Table VIII, column D. Each of the components which had been ballistically impacted was cyclic loaded for 2,000 cycles and tested with loads as shown in Table VIII, column D. Figures 35 through 38 show the test setup for each of the components.

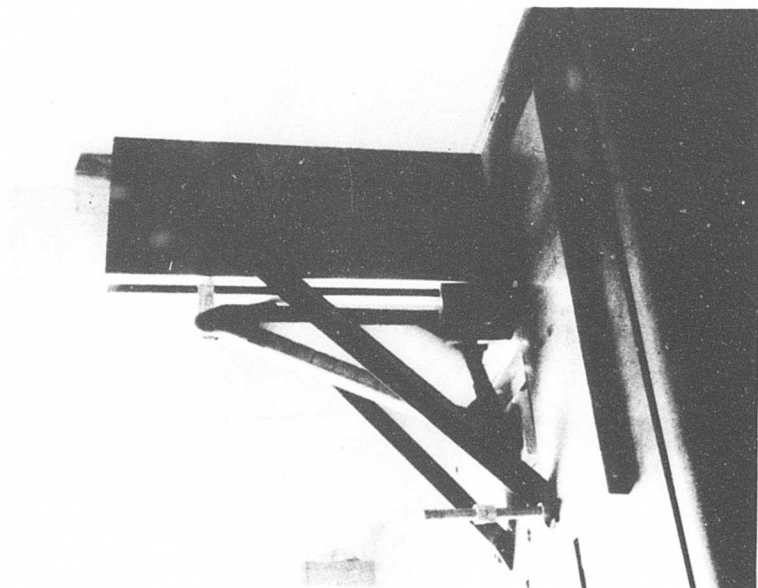
Figure 36. Cyclic Loading of Forward Bell Crank.

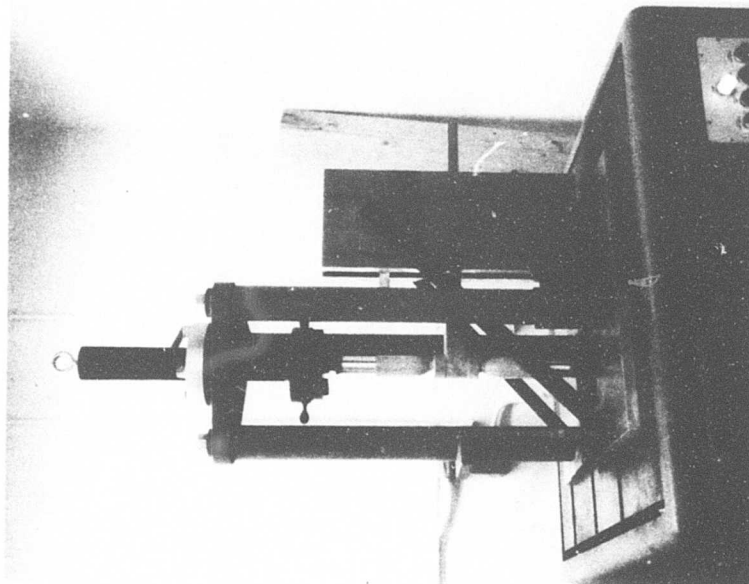
Figure 38. Cyclic Loading of Idler Assembly.

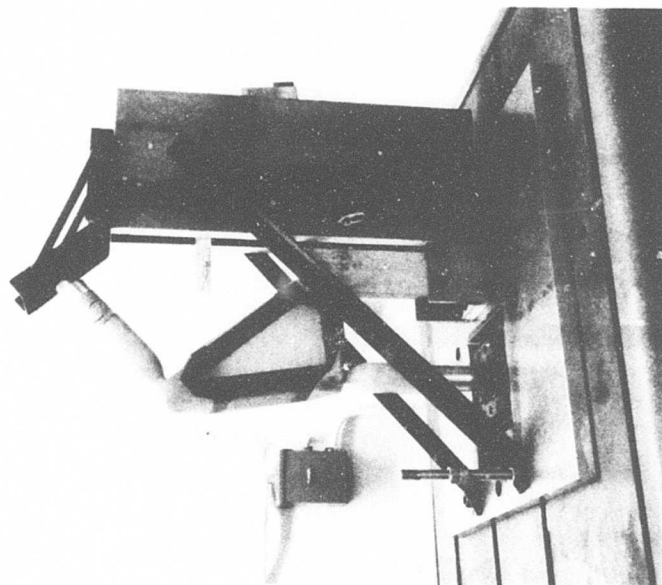
Figure 37. Cyclic Loading of Aft Bell Crank.

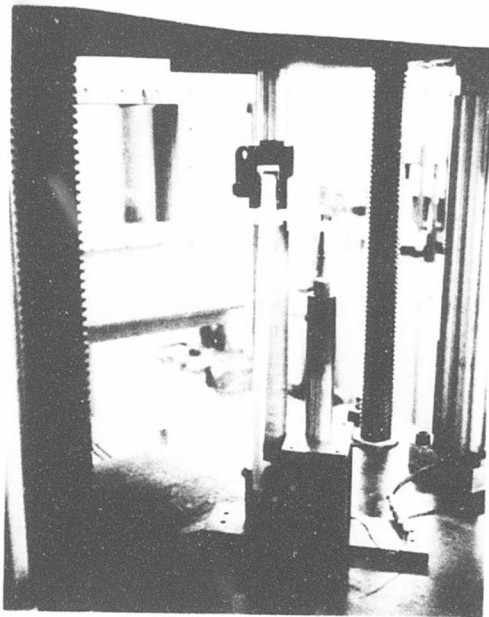
Figure 39. Test Setup for Connecting Link.

Figure 39 shows a typical static loading test being performed on a connecting link assembly. The detail at the right-hand portion of the assembly is an extensometer for measuring load/deflection during the test. Figure 40 shows a typical failure of the connecting link.

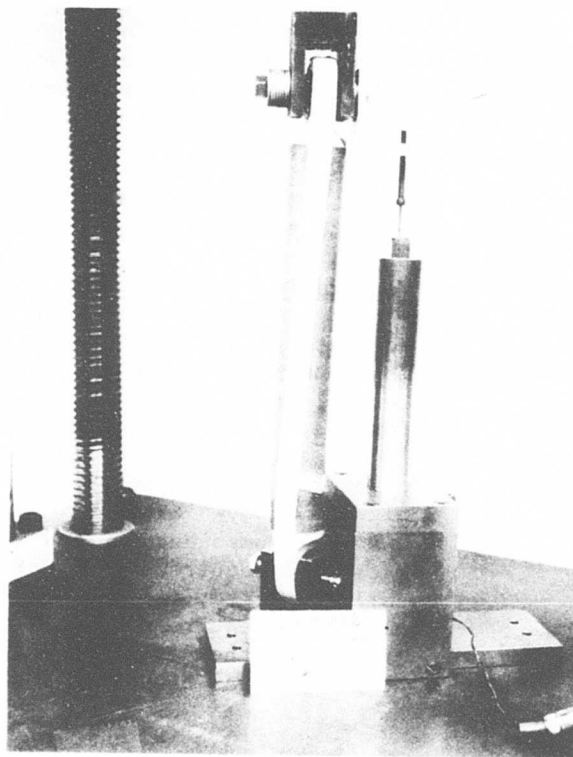
Figure 40. Failed Connecting Link.

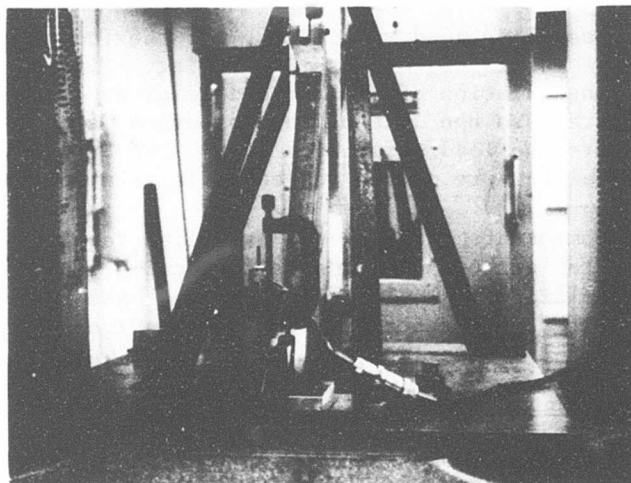
Figure 41. Test Setup for Forward Bell Crank.

The base line requirement for the forward bell crank assembly is a compressive load of -2,070 lb. Figure 41 shows the typical installation of the forward bell crank in the test fixture. In the front left portion of the picture is the extensometer which is mounted directly at the pivot fitting for measuring load/deflection during the test. Figure 42 shows a typical failure of the connecting link assembly. All components tested met or exceeded the base line ultimate load requirements. Set no. 2, which had been ballistically impacted, failed at 2,080 lb, just slightly above the base line requirement. All other components failed in excess of 200% of the base line load. The spread for the remaining components was between 4,000 and 4,900 lb.

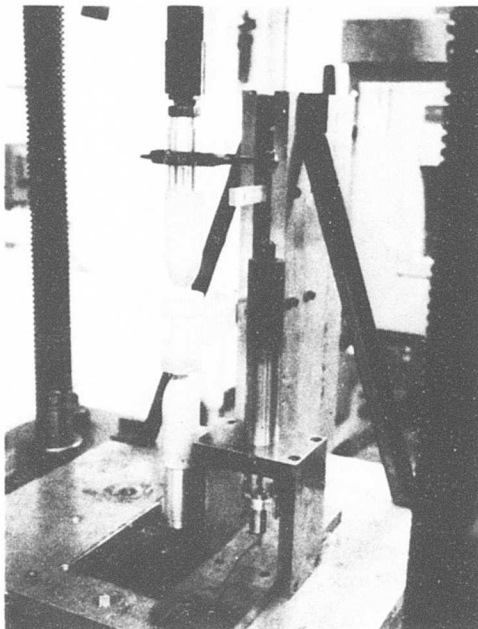
Figure 43. Test Setup for Idler Assembly.

The base line load requirement for the rod end idler arm assembly is -4,013 lb compressive loading. Figure 43 shows a typical installation of the rod end idler arm assembly in the test fixture. To the left of the component is the apparatus used to measure the load/deflection during the test. Figure 44 is a typical failure of the rod end idler arm assembly.

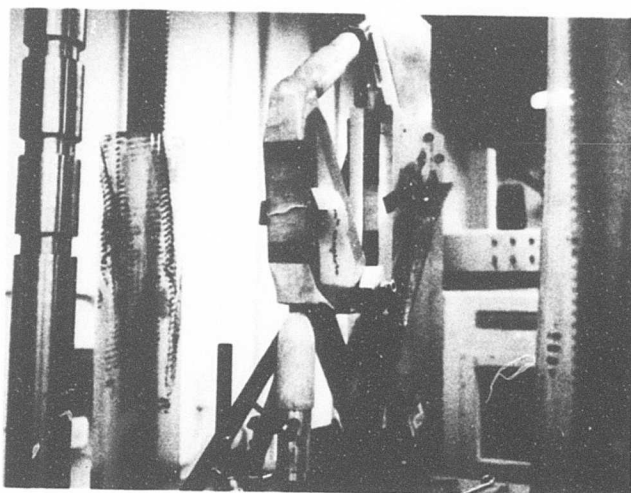
Figure 45. Test Setup and Type Failure of Aft Bell Crank.

The base line load requirement for the aft bell crank assembly is -4,013 lb compressive loading. Figure 45 shows the typical installation of the aft bell crank assembly for static failure loading test and one of the types of failures. Figure 46 shows another type of failure in the rod end detail.

Some components failed to meet the static base line requirement. Two of these, the component that had been through ballistic impact test and that which had been exposed to the fire resistance tests, were not expected to perform satisfactorily due to the excessive damage incurred by the previous tests. The ballistically impacted component withstood a load of -1060 lb and had high deflections. The reason for this was the removal of approximately three-fourths of the socket portion of the input fitting; there also had been considerable fracture of the face sheet bonds during the ballistic impact test. The component which had been exposed to the fire resistance test performed better than expected, failing at a load of 3,280 lb, with a total deflection of 136 mil. There was, however, an unexpectedly low failure with set no. 5, which had been through the humidity, sand and dust, fungus, and salt spray exposures. This component failed in the rod end fitting at the pilot input end. Its failure mode is shown in Figure 46. The deflections were in line with the best performing components, and it is suspected that a manufacturing defect was responsible for this low failure load (2,290 lb), possibly poor adhesion between the BMC and the unidirectional insert. Failures in this same area occurred in the rod ends of the idler arm but at much higher loads.

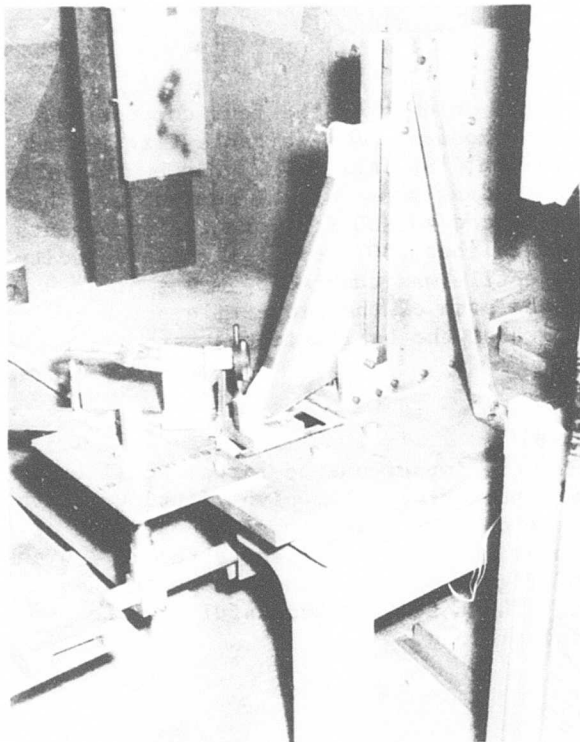
Figure 47. Forward Bell Crank  
Before Impact.

The target area for the ballistic impact on the forward bell crank assembly was the rectangular tube between the pivot fitting and the outboard clevis fitting. The objective was to sever one-half of the rectangular tube cross section. Figure 47 shows the bell crank installed in the fixture, and Figure 48 shows the damage to this area after ballistic impact. The test was successful and the component maintained the initial preload.

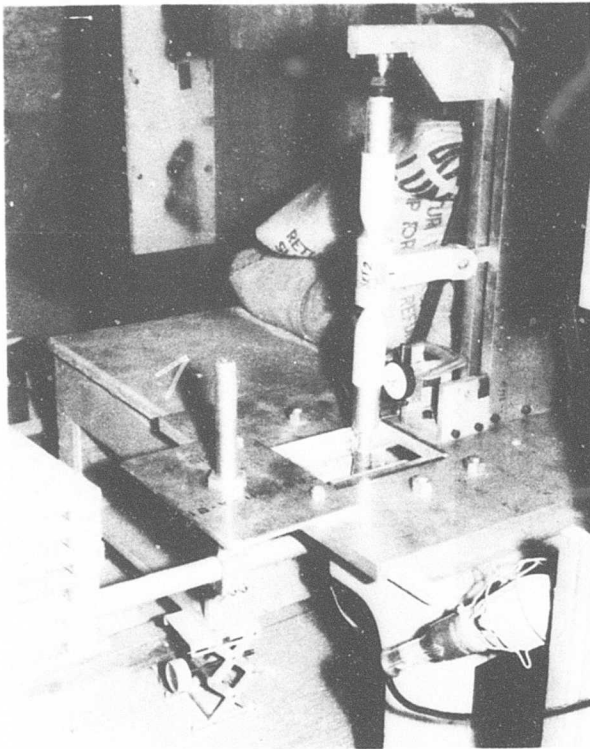
Figure 49. Rod End Idler Arm Before Impact.

The rod end idler arm assembly was positioned in a fixture and loaded as shown in Figure 49. The target for the ballistic impact was the very center of the ball and socket joint on the lower side. The test was successful in that the tumbled projectile hit nearly dead center, as shown in Figure 50. However, the projectile ricocheted off the ball, severing a portion of the molded idler arm assembly. The component withstood the impact and was still operational.

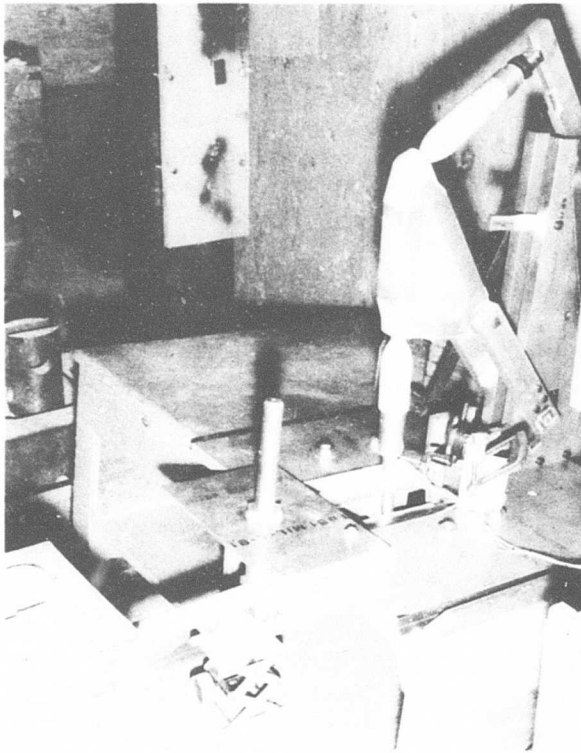
Figure 51. Aft Bell Crank  
Before Impact.

The aft bell crank assembly was positioned in the fixture and loaded as shown in Figure 51. The target for the ballistic impact was the center of the ball and socket joint at the input fitting. In the first test, the projectile hit approximately 0.4 inch below in a tumbled fashion. In this area it impacted the retainer ring and completely severed it from the rest of the assembly. No further damage was incurred; however, the ball was completely loose from the socket and would not permit further testing. Observation of the failure indicated that the projectile, when penetrating the retainer ring, had made contact with the unidirectional glass wrapped reinforcement around the retainer and appeared to have unwrapped this reinforcement on its path through the part. A second test was performed

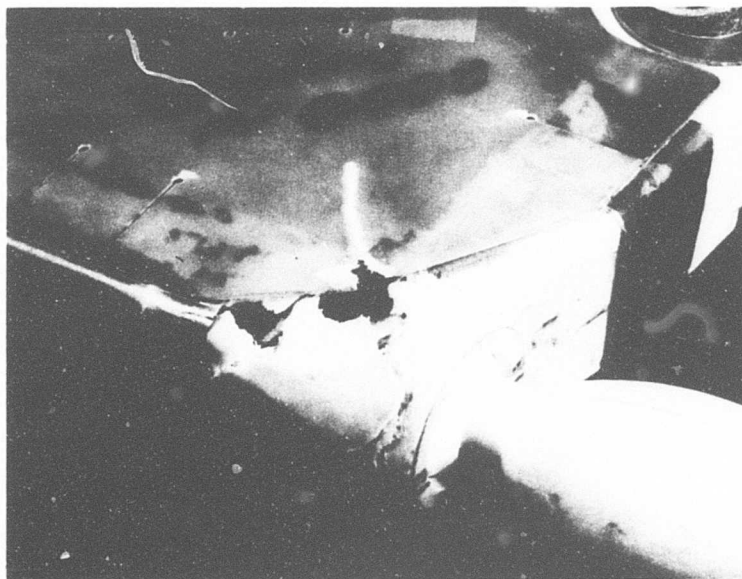
Figure 52. Aft Bell  
Crank  
After  
Impact.

in an attempt to achieve a hit more centered on the ball and socket joint. The component for this test was the aft bellcrank assembly that had been exposed to the ultraviolet radiation condition. During the second test, the tumbled projectile hit directly on the center of the ball and socket joint and ricocheted inward. While there was minimal damage to the ball itself, it did stop the projectile, leaving the jacket and lead fragments inside the bell crank cavity. While absorbing this impact, considerable damage was incurred in the molded fitting. However, the bell crank was still operational. Figure 52 is a picture of the damage incurred on the second ballistic test.

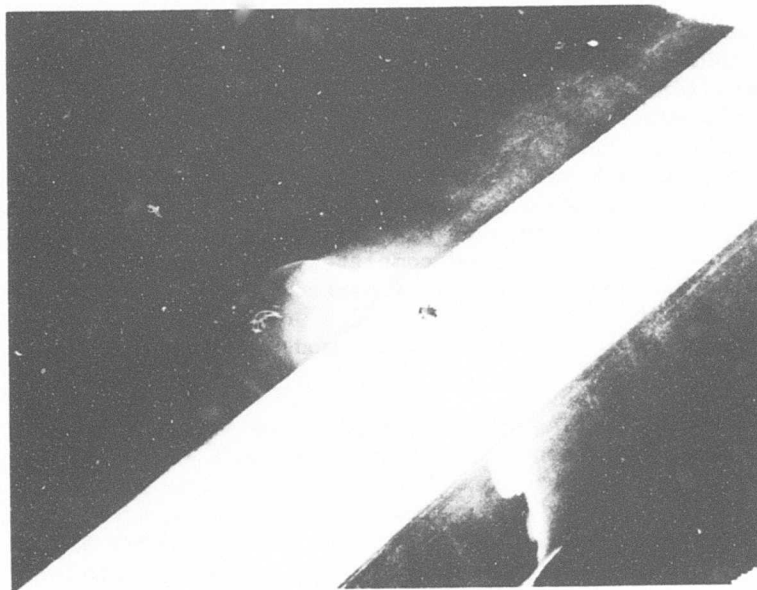
Figure 53. Connecting Link After Ballistic Impact and Static Failure Test.

A second connecting link was positioned in the fixture and was impacted with a nontumbled projectile such that the strap portion was penetrated properly. The second test was successful in that the bullet cleanly penetrated the reinforcing strap and cleanly exited through the back side of the wall. Figure 53 is a picture of the damage incurred on the second connecting link and the failure after static loading. The test was successful in that after impact the component continued to carry the initial preload.
